## Wingfield Whitewater Park Maintenance – Truckee River

**PREPARED FOR:** Reno Recreation and Park Commission

**PREPARED BY:** Gary Lacy, PE - Recreation Engineering & Planning, Inc. (REP)

## Wingfield Whitewater Park Maintenance Recommendations

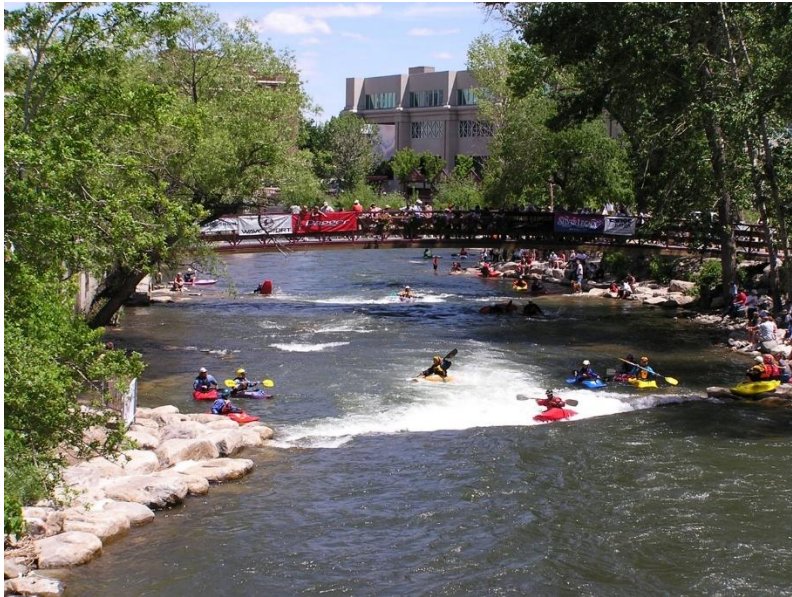
Drop structure 3 is located immediately downstream of the Arlington Avenue Bridge, in the north channel. Drop structure 4 is located downstream of the pedestrian bridge. Sediment has accumulated in the channel below drop structure 3 and drop structure 4, impacting the hydraulic character of the drop and filling in eddies. See photos below of original and current conditions.

Original design: Deep water downstream of Drop Structure 3, pronounced Drop Structure 4 is visible downstream of pedestrian bridge.

REP recommends excavating accumulated sediment in the pools below Drop Structure 3 and 4 to restore the design river thalweg and cross section elevations. **Remaining flood debris shall be removed from the channel.** At Drop Structure 5, REP recommends restoration of the tailwater control structure with large diameter boulders, installed with large diameter toe boulders to provide tailwater control in conformance with the original design and prevent future degradation.

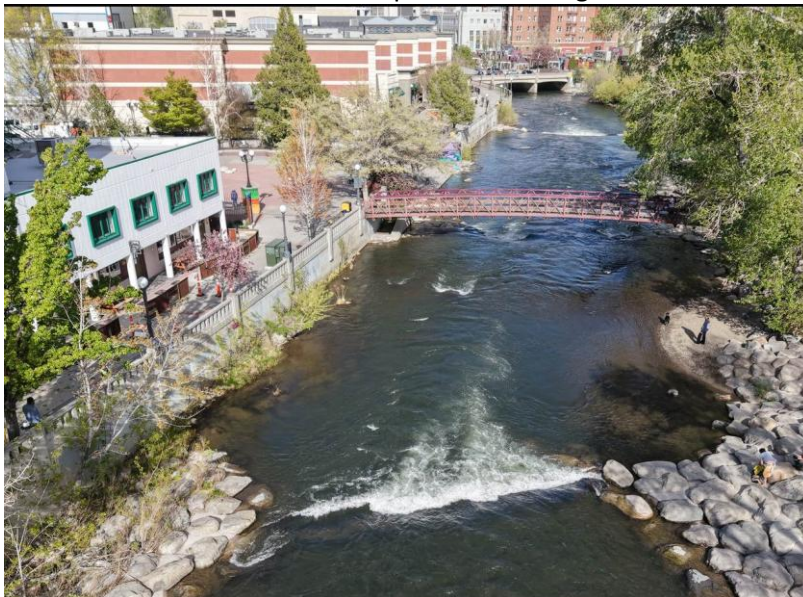
Current Conditions: Accumulated sediment, especially evident at right bank. Drop Structure 4 is drowned out due to downstream deposition.

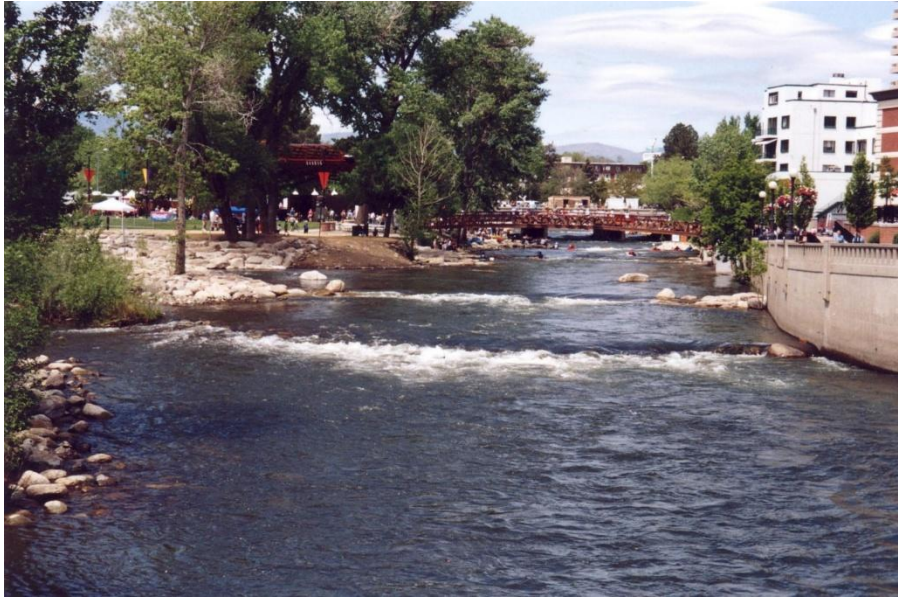
Original Design: Tailwater control structure in foreground, drop structure 5 in background.

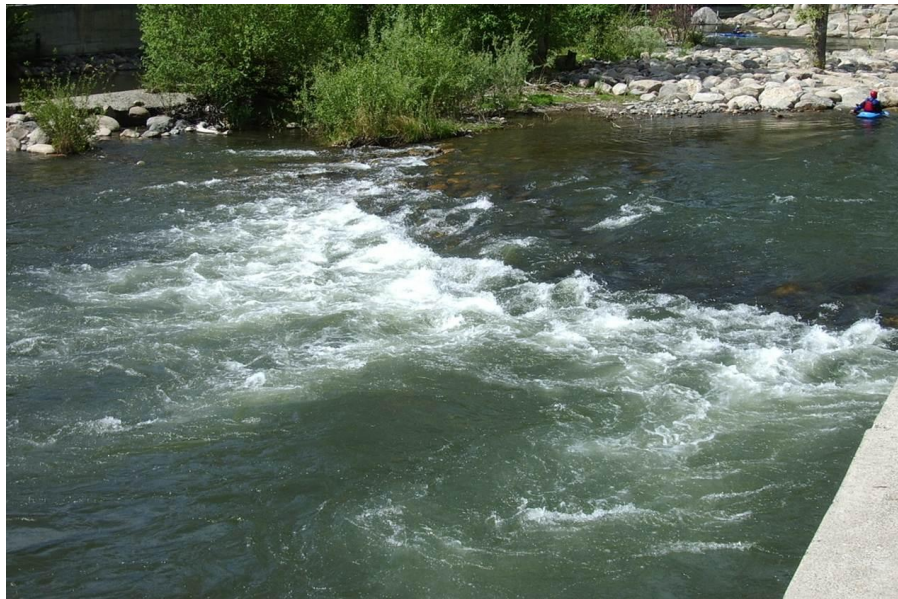
Original Design: Tailwater control structure maintaining grade upstream (right)

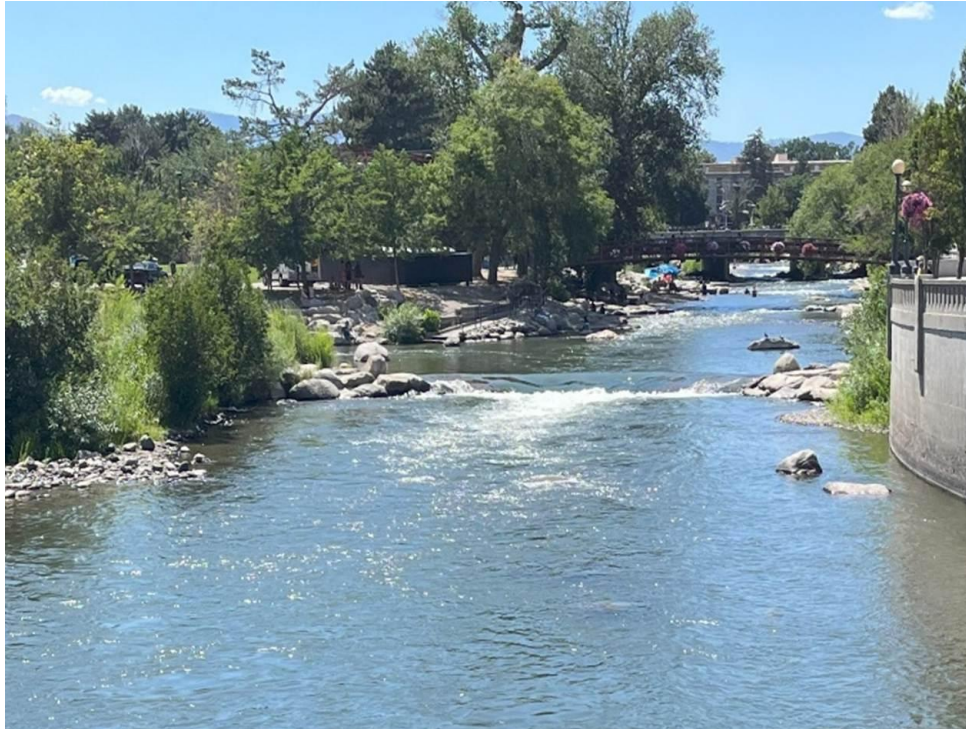
Current Conditions: Remaining tailwater control boulders visible at the left flood wall and right bank, but thalweg is impacted such that grade control is no longer provided.

The impact of the degradation of the tailwater control structure is that drop structure 5 no longer functions as designed. A recirculating hydraulic is formed due to water plunging off of the drop structure face. The resulting hydraulic can capsize watercraft and be retentive to watercraft or swimmers. With few river exit points available downstream, a capsize in this location would be difficult to recover. Restoration of this structure to its original function is recommended to protect public safety.

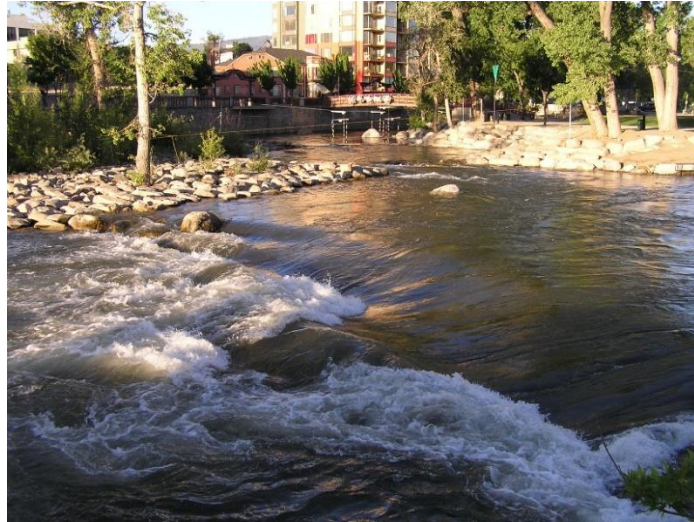
Original Design: Wave type hydraulic jump, lower overall drop across the structure

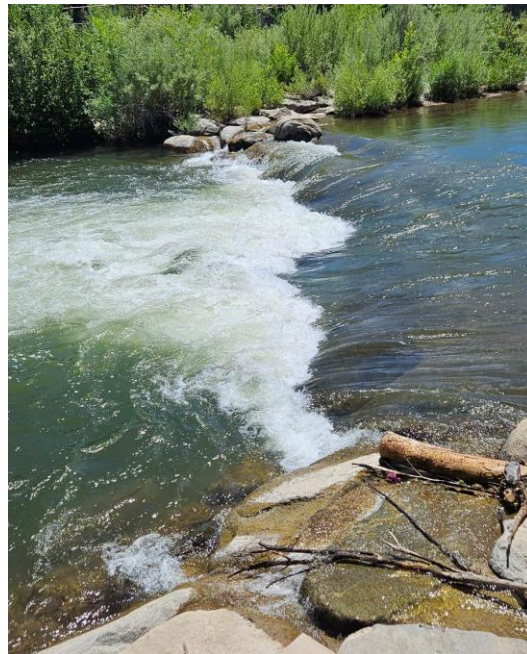
Current Conditions: Recirculating, powerful "plunging conditions" hydraulic jump due to dropping off the end of the structure and higher than designed head differential

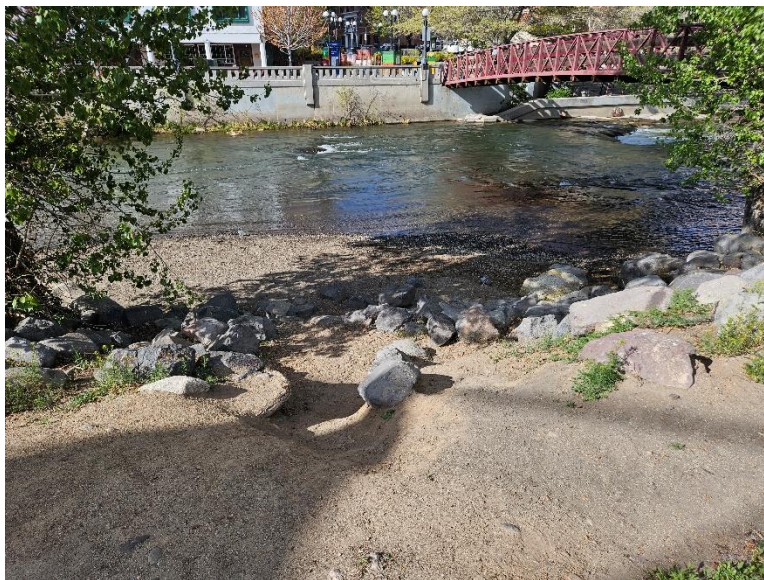
Upland of pool 3, the concrete path narrows to 6' width. This is a bottleneck for the otherwise 10' wide paths throughout Wingfield Park. 10' is the minimum width for a bidirectional shared use path per AASHTO standards. The abrupt narrowing, and non-conformance with shared use path standards has caused erosion on both sides as users must tread next to the relatively narrow concrete. On the north side, this is contributing to erosion of the bank. North of the path, users accessing the pool below drop 3 have also contributed to erosion down the bank.

Eroded path down to pool 3

Recommended upland improvements include widening the existing concrete path to 10' to be consistent with the other onsite paths, constructing a boulder edge treatment on the river facing side of the path to prevent future riverbank erosion, and resetting boulder terracing on the eroded user trail to pool 3.
